A HISTORY OF FULL-SCALE TESTING OF AIRCRAFT STRUCTURES AT THE NATIONAL AERONAUTICAL ESTABLISHMENT

R.L. Hewitt

National Aeronautical Establishment

AERONAUTICAL NOTE
NAE-AN-24
NRC NO. 24089

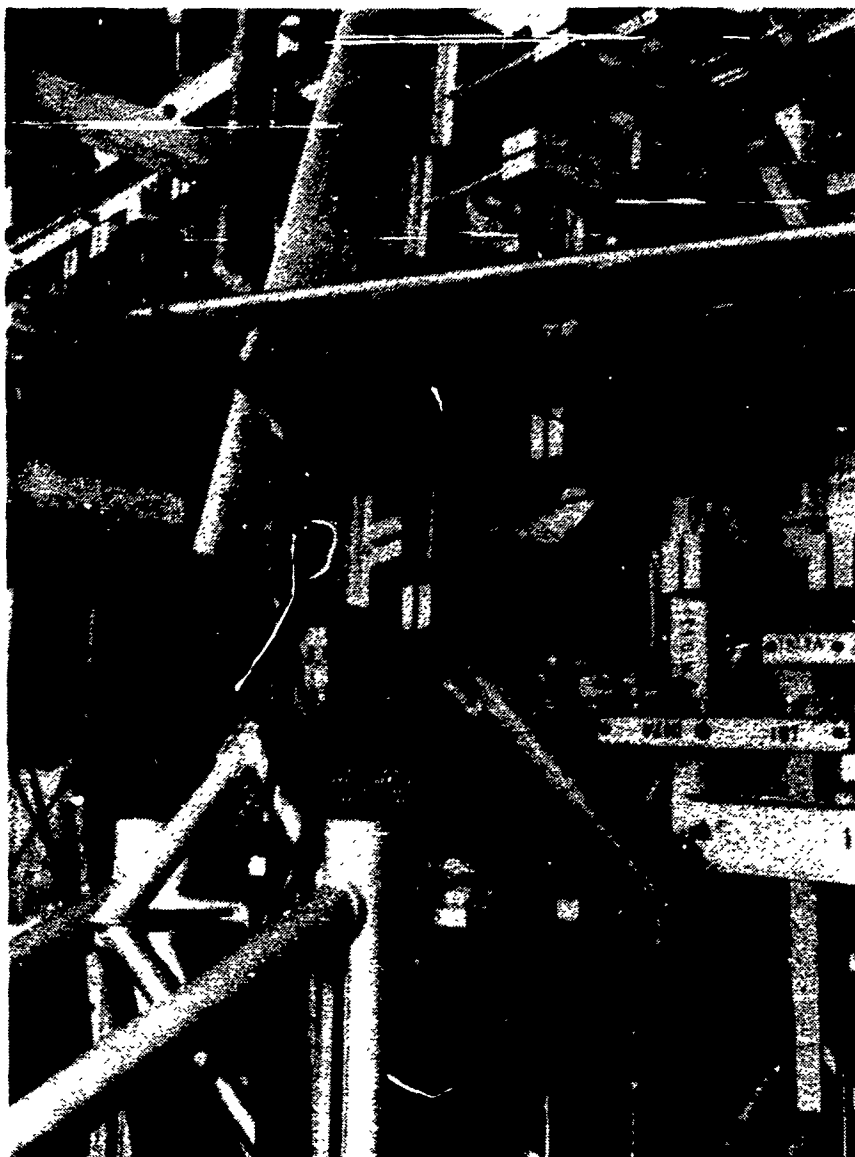
FIG. 24: C-100 EMPENNAGE UNDER PROOF LOAD

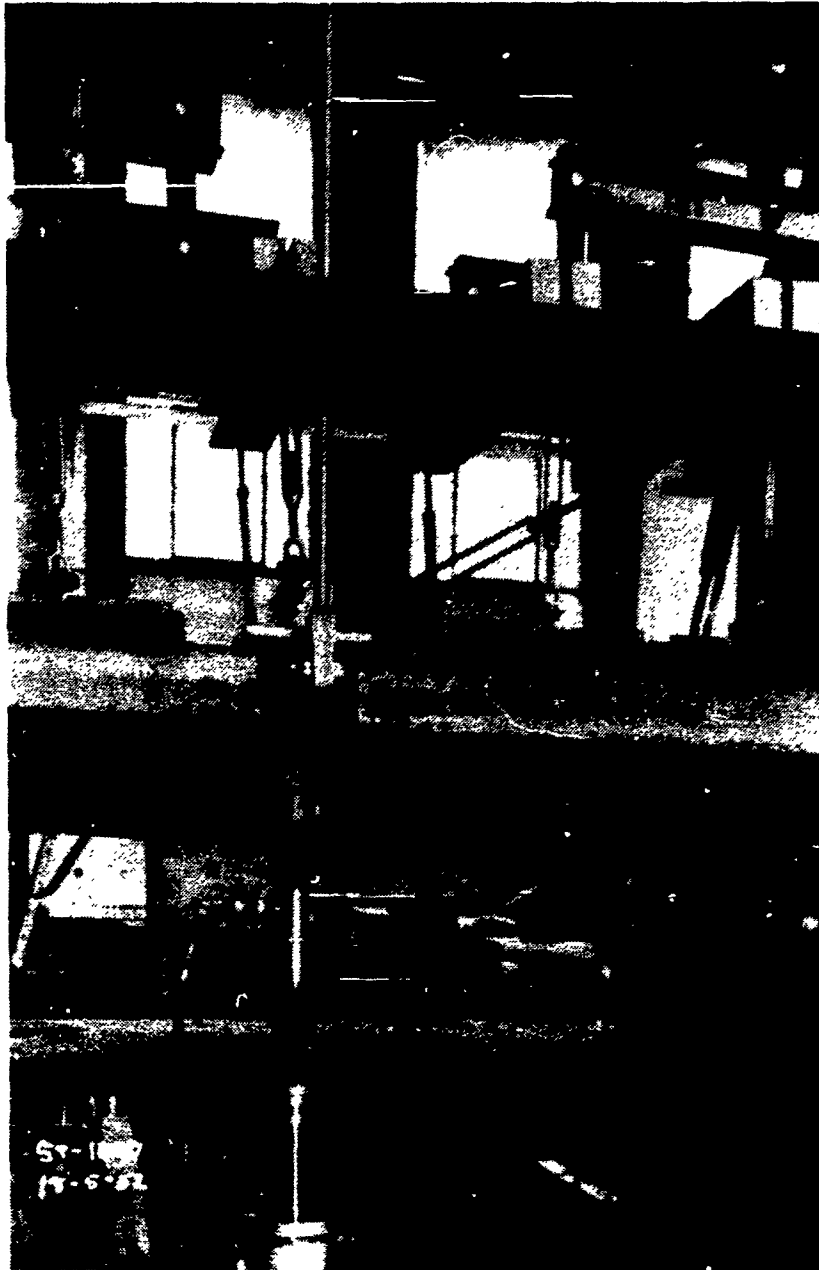
FIG. 25: LOADING AT THE CENTRE ELEVATOR HINGE OF C-100 TAILPLANE SHOWING APPLICATION OF A COUPLE TO THE HINGE AND CLOSE-UP OF LOAD CELL

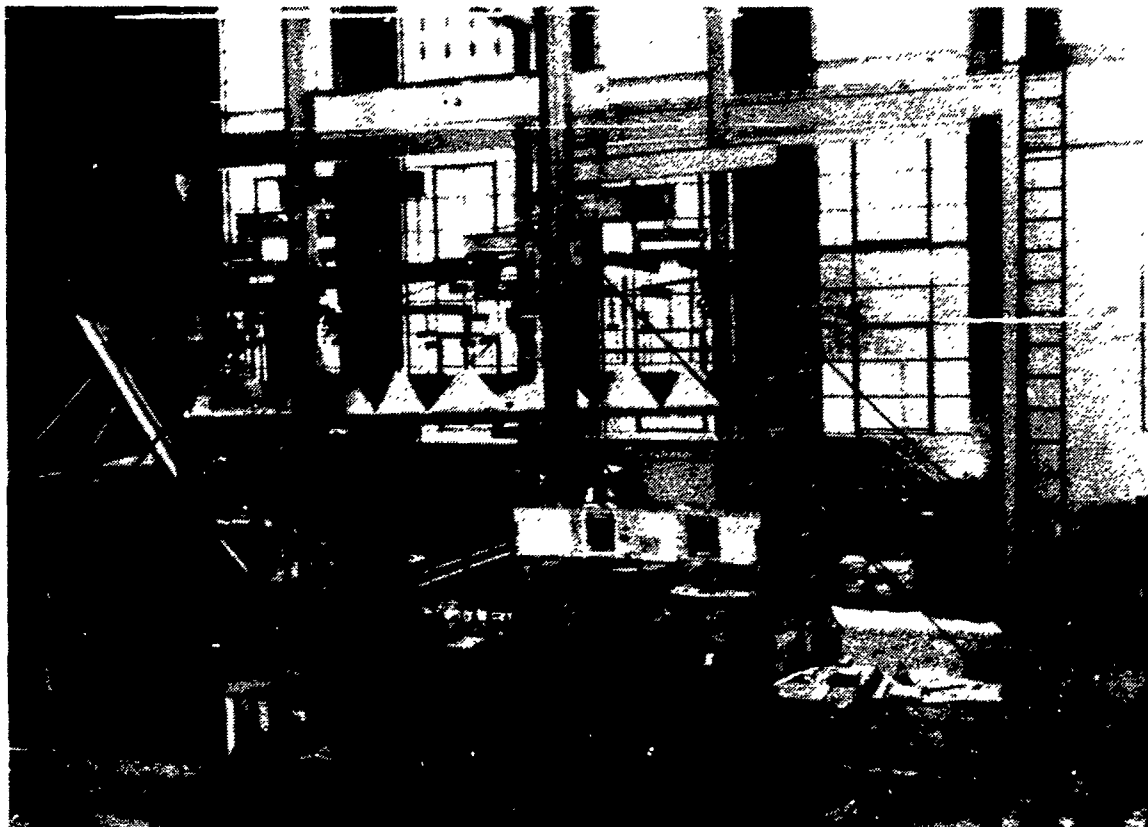
FIG. 26: AUTOMATED REPEATED LIMIT LOAD TEST ON C-100 MARK 3 OUTER WING

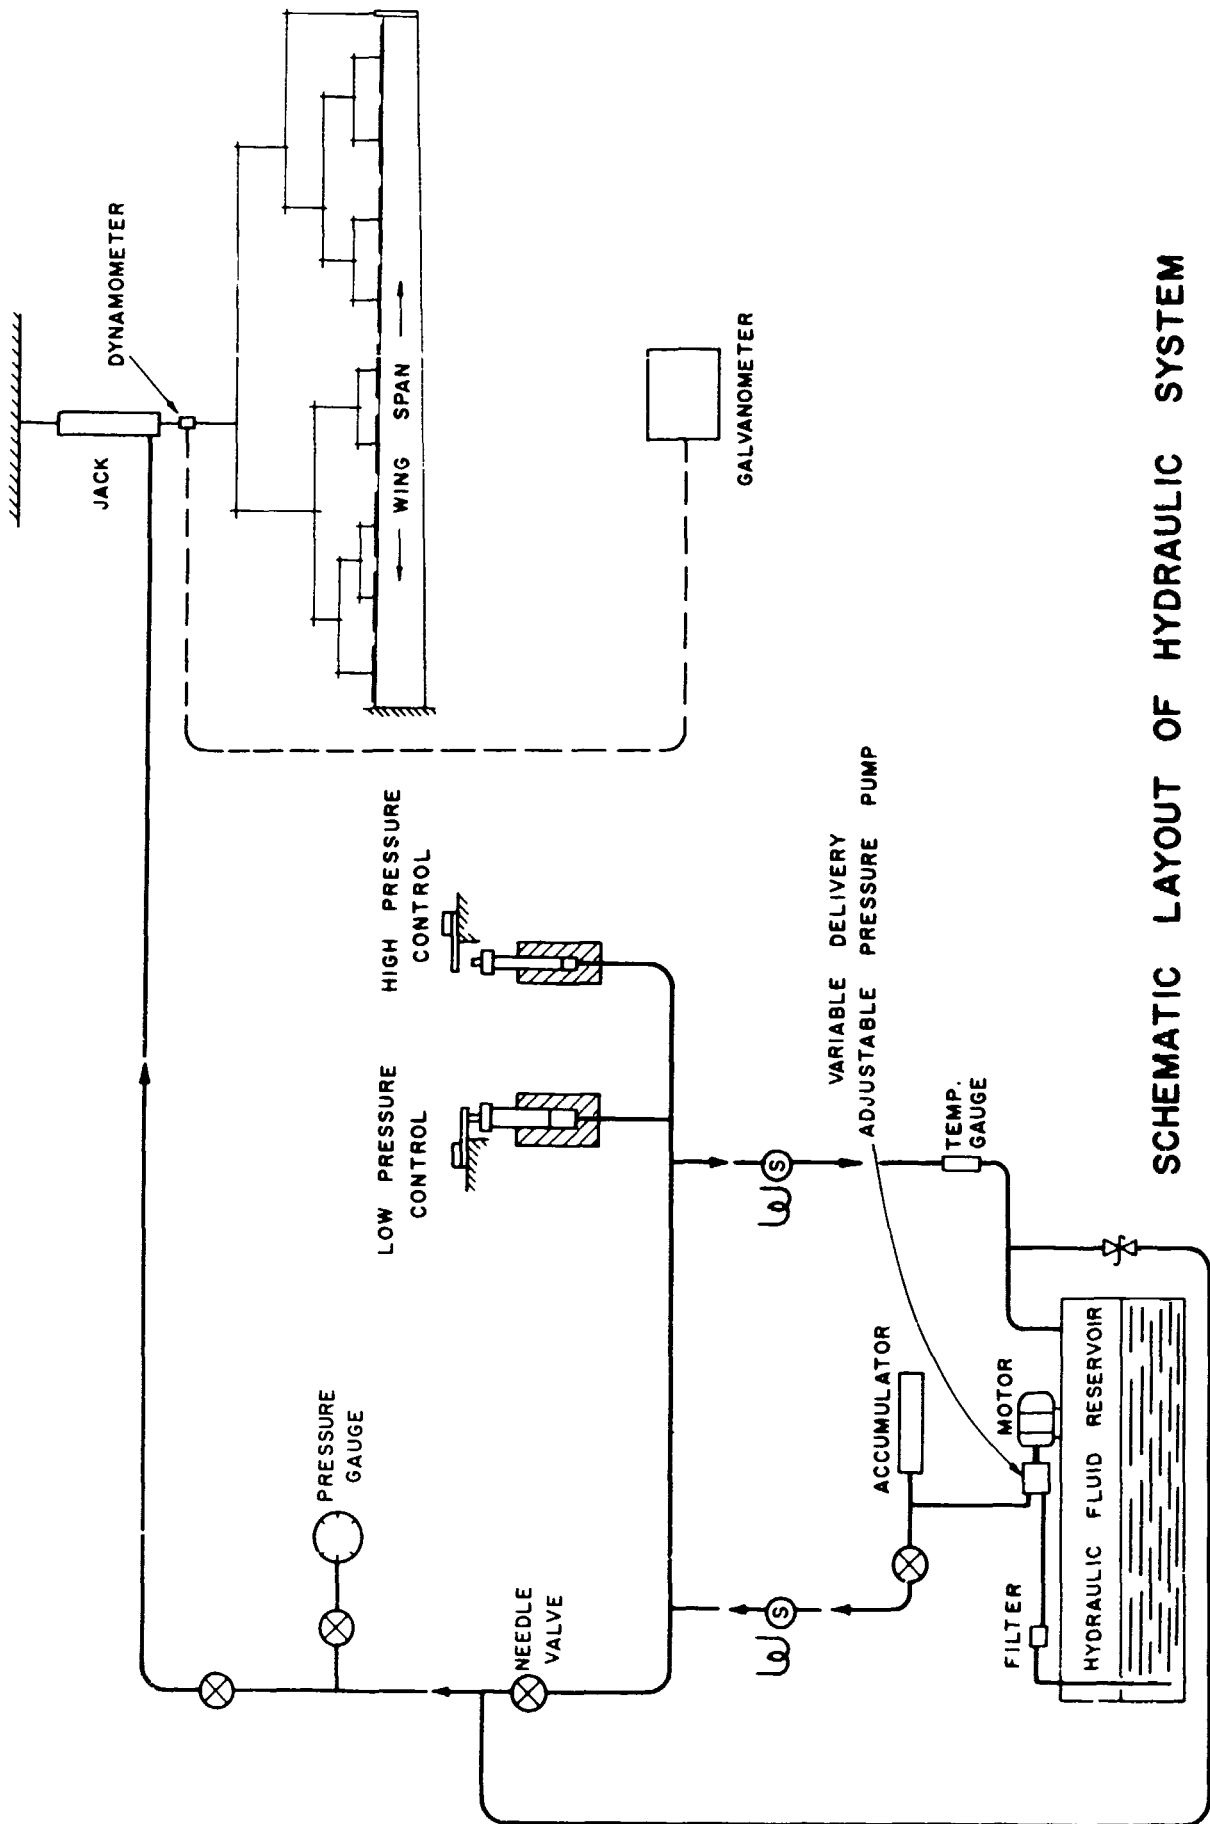
SCHEMATIC LAYOUT OF HYDRAULIC SYSTEM

FIG. 27: AUTOMATIC LOADING SYSTEM FOR REPEATED LOAD TESTS

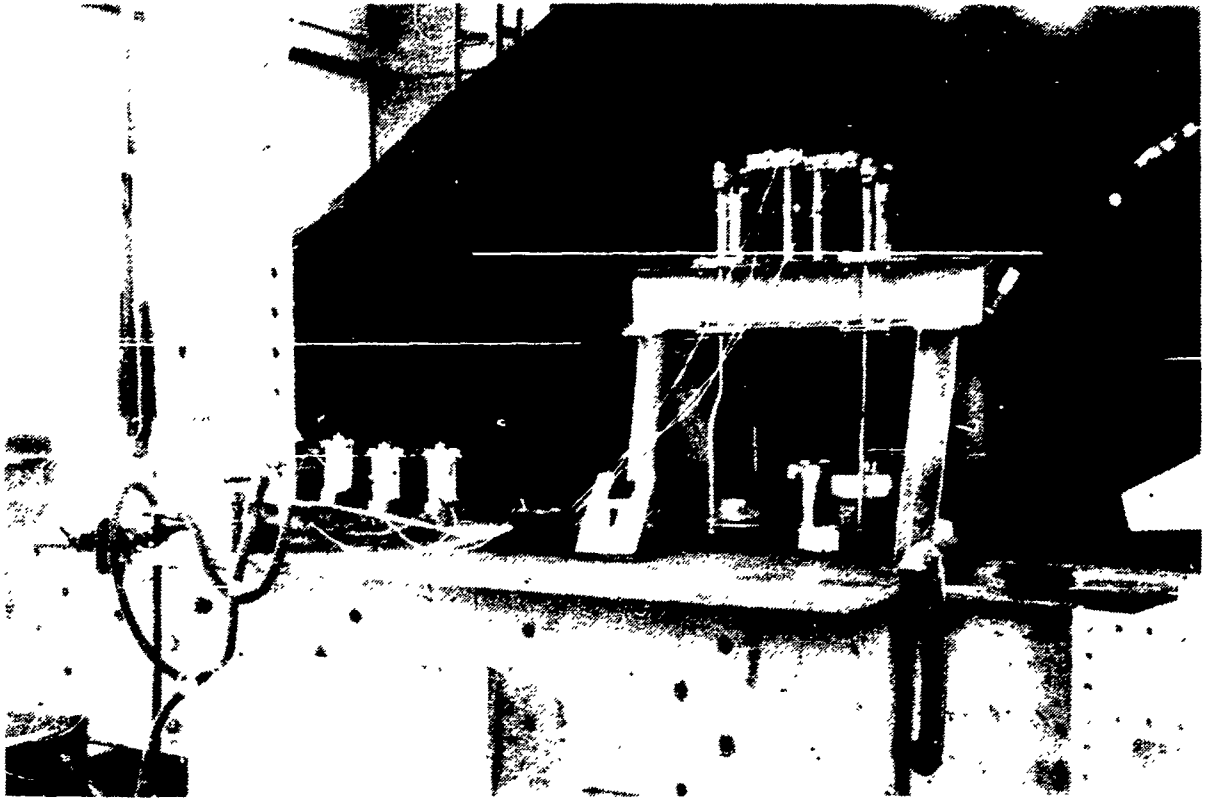
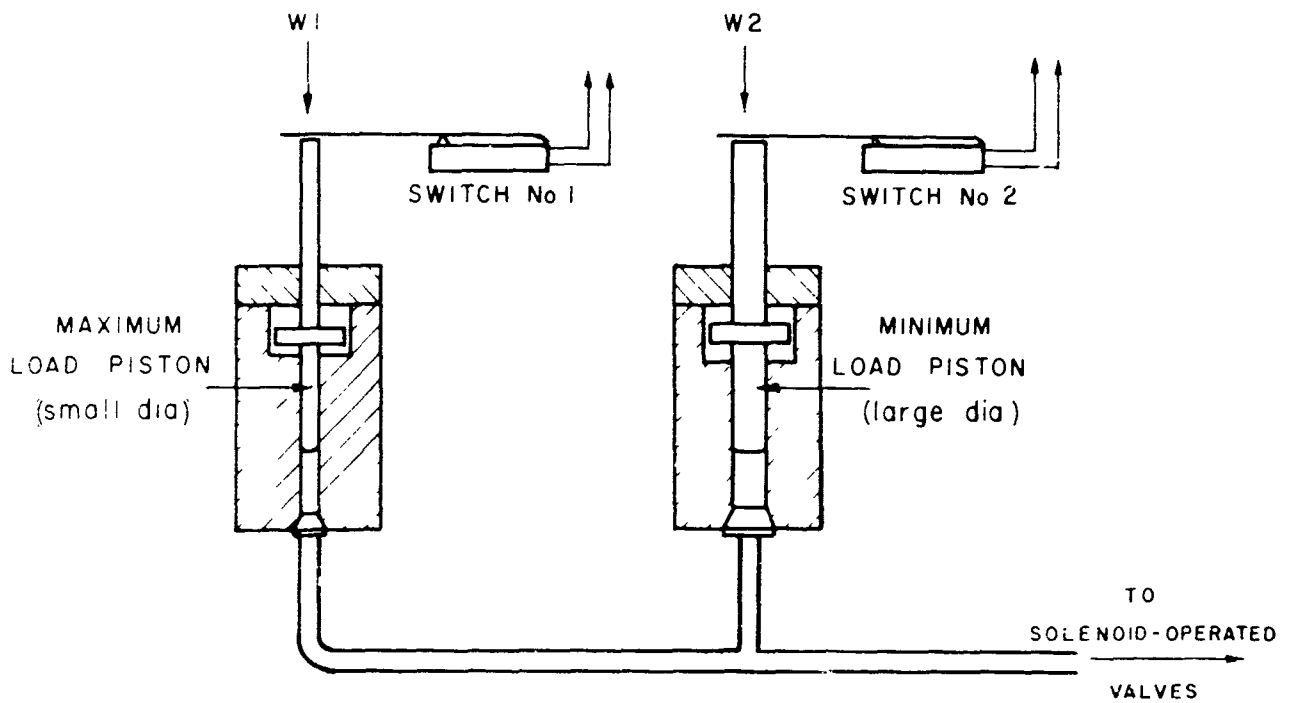
FIG. 28: PHOTOGRAPH AND SCHEMATIC OF REPEATED LOAD BALANCING SYSTEM

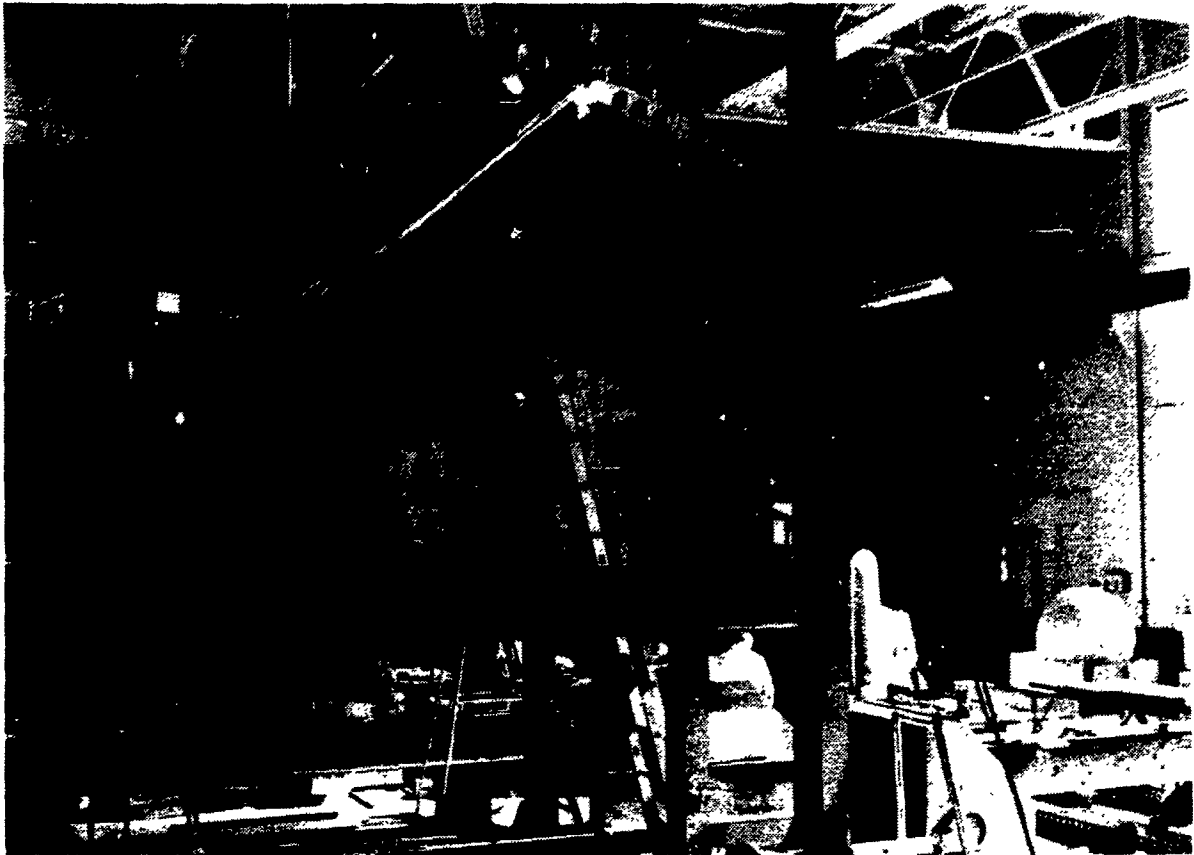
FIG. 29: STATIC TEST SET-UP FOR FOUND BROTHERS FBA-2 AIRFRAME

tubular fuselage frame, excluding wing tip fairings, flaps and ailerons. Additional triangulated frames of light steel sections were attached to the forward and aft faces of the centre fuselage in order to apply the necessary nose and tail loads required for balance. The specimen was mounted in a freely-suspended condition in the gallows frames, being supported from the overhead beams by means of whiffletrees between hydraulic jacks on the frame and tension patches bonded to the upper wing surface. Down loads were applied to the fuselage floor by means of rods and plates leading to a fuselage whiffletree system. Nose and tail loads were applied at their relevant angles to the fuselage datum line by flat steel links connected to hydraulic jacks located on the centre-line of the aircraft in the base of the test rig. The test arrangement is shown in Figure 29.

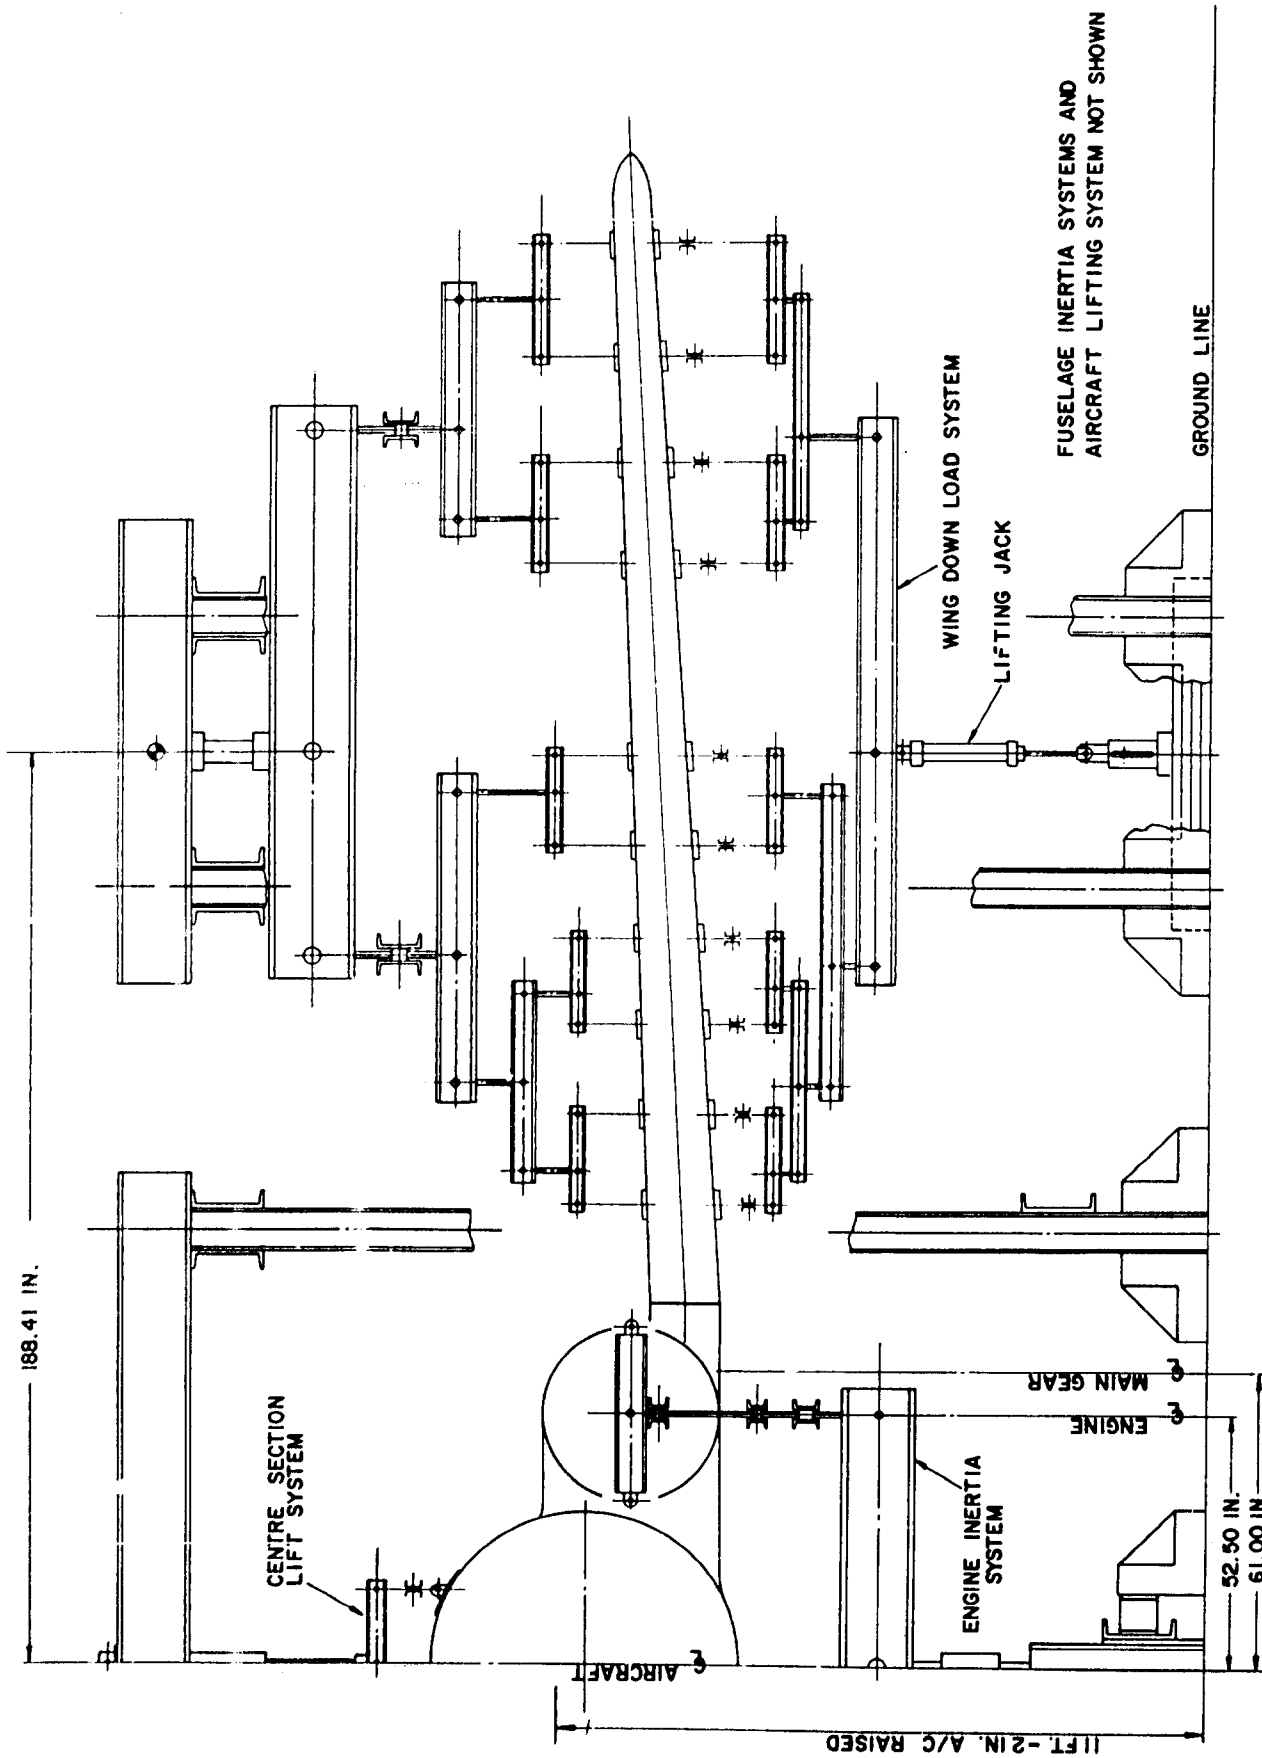
FIG. 30: C-100 WING-FUSELAGE TEST ARRANGEMENT - FRONT ELEVATION

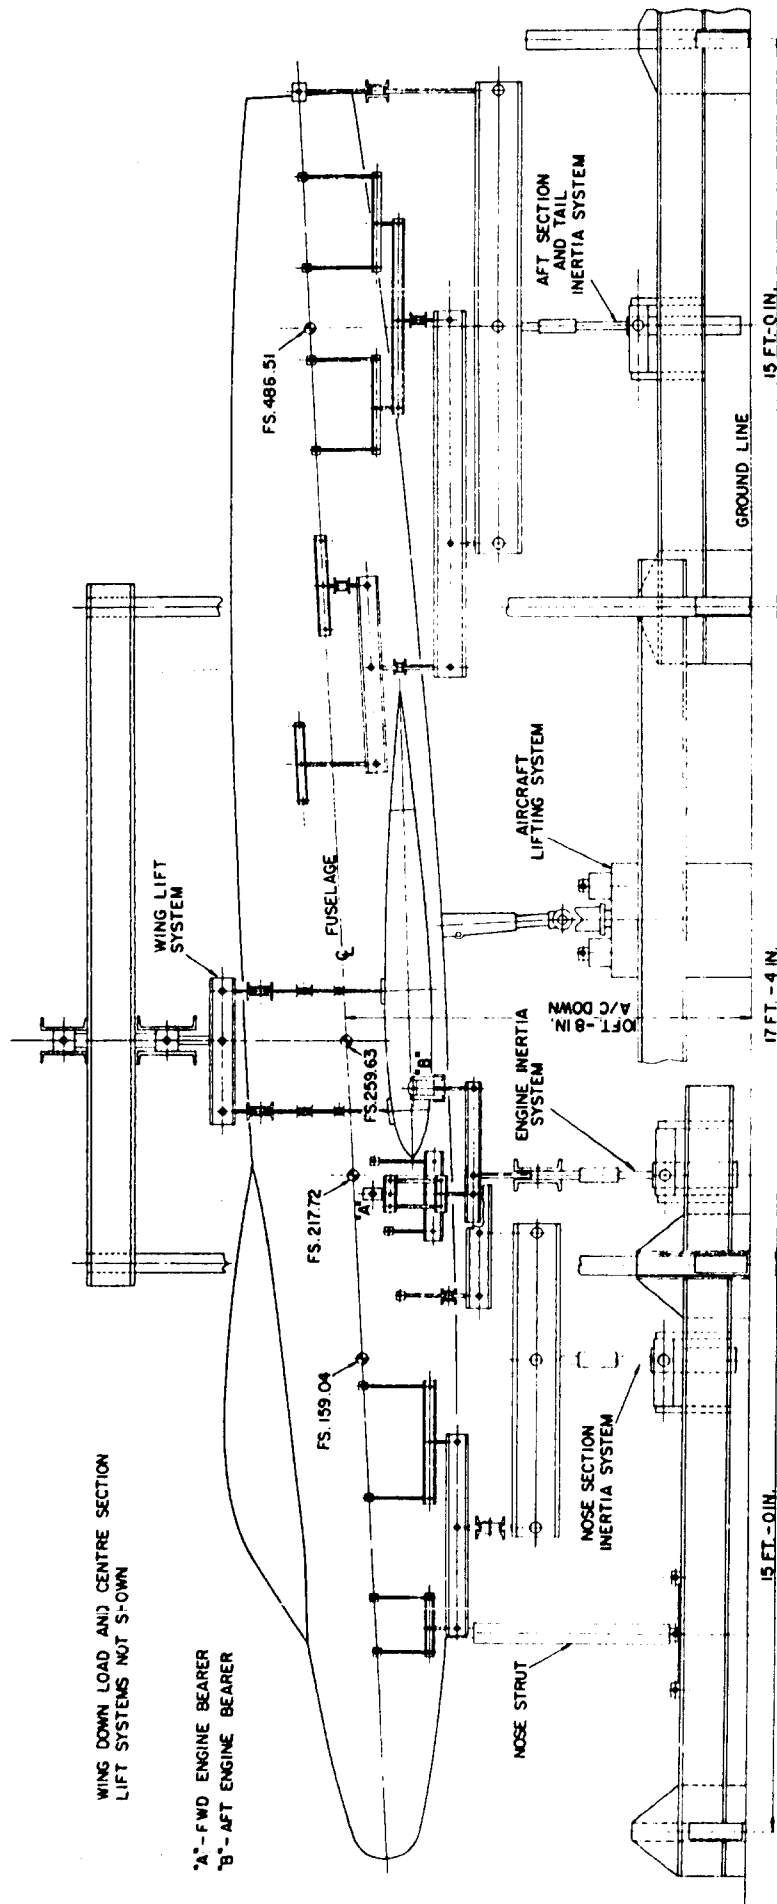
FIG. 31: C-100 WING-FUSELAGE TEST ARRANGEMENT - SIDE ELEVATION

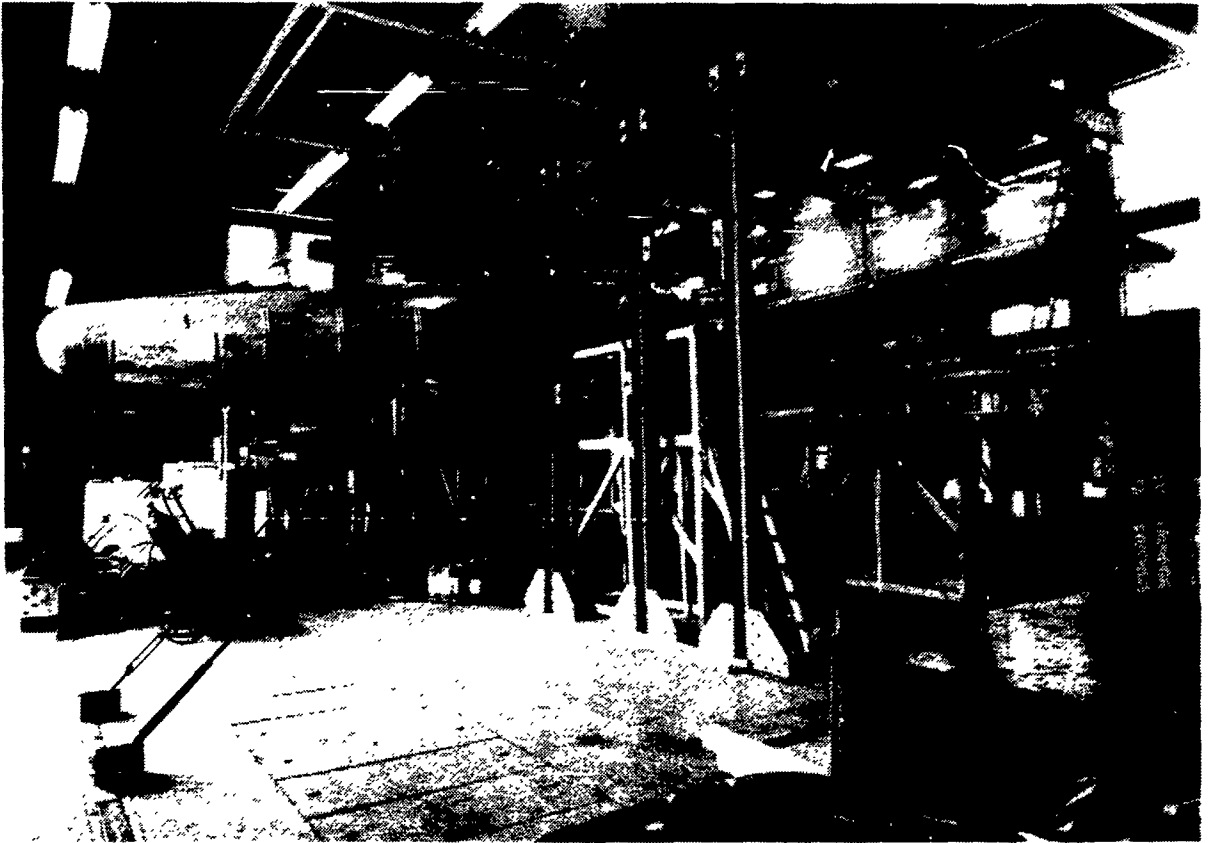
FIG. 32: C-100 WING-FUSELAGE FATIGUE TEST ARRANGEMENT

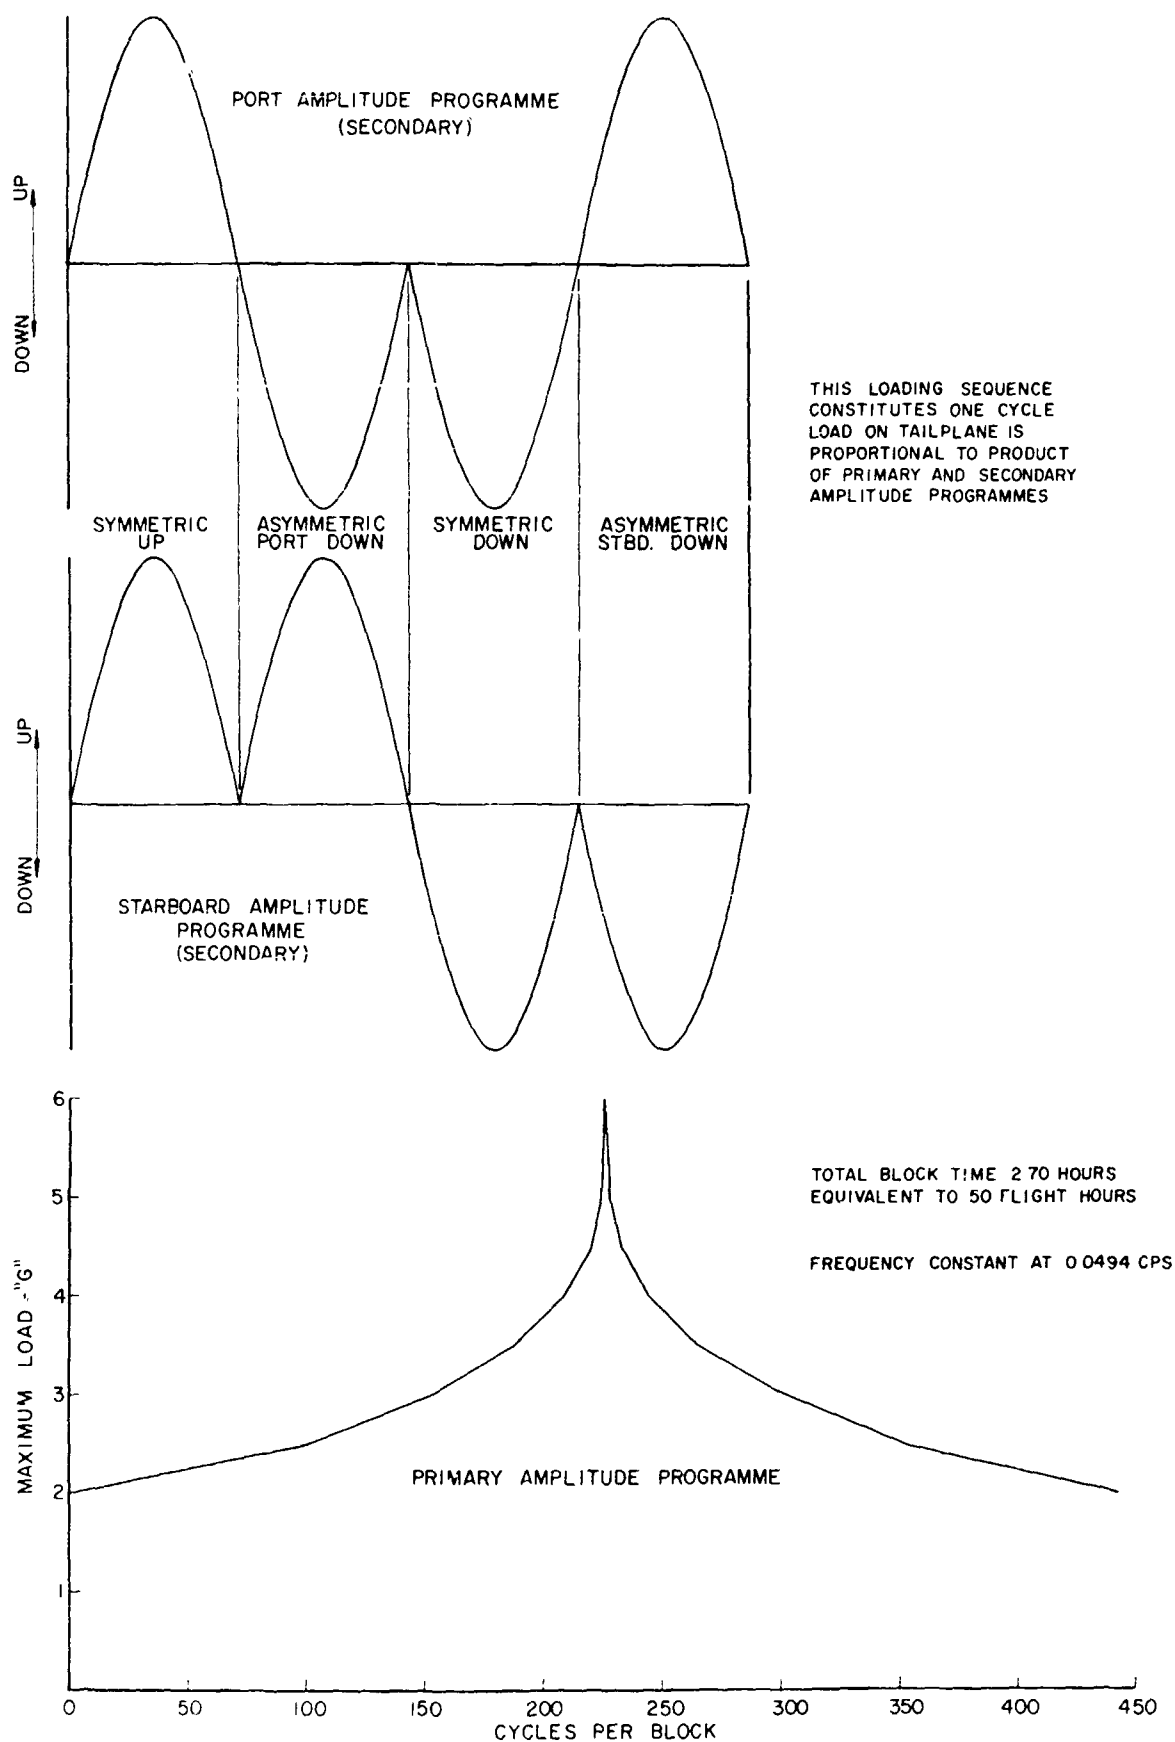
FIG. 33: TEST LOAD HISTORY FOR C-100 TAILPLANE

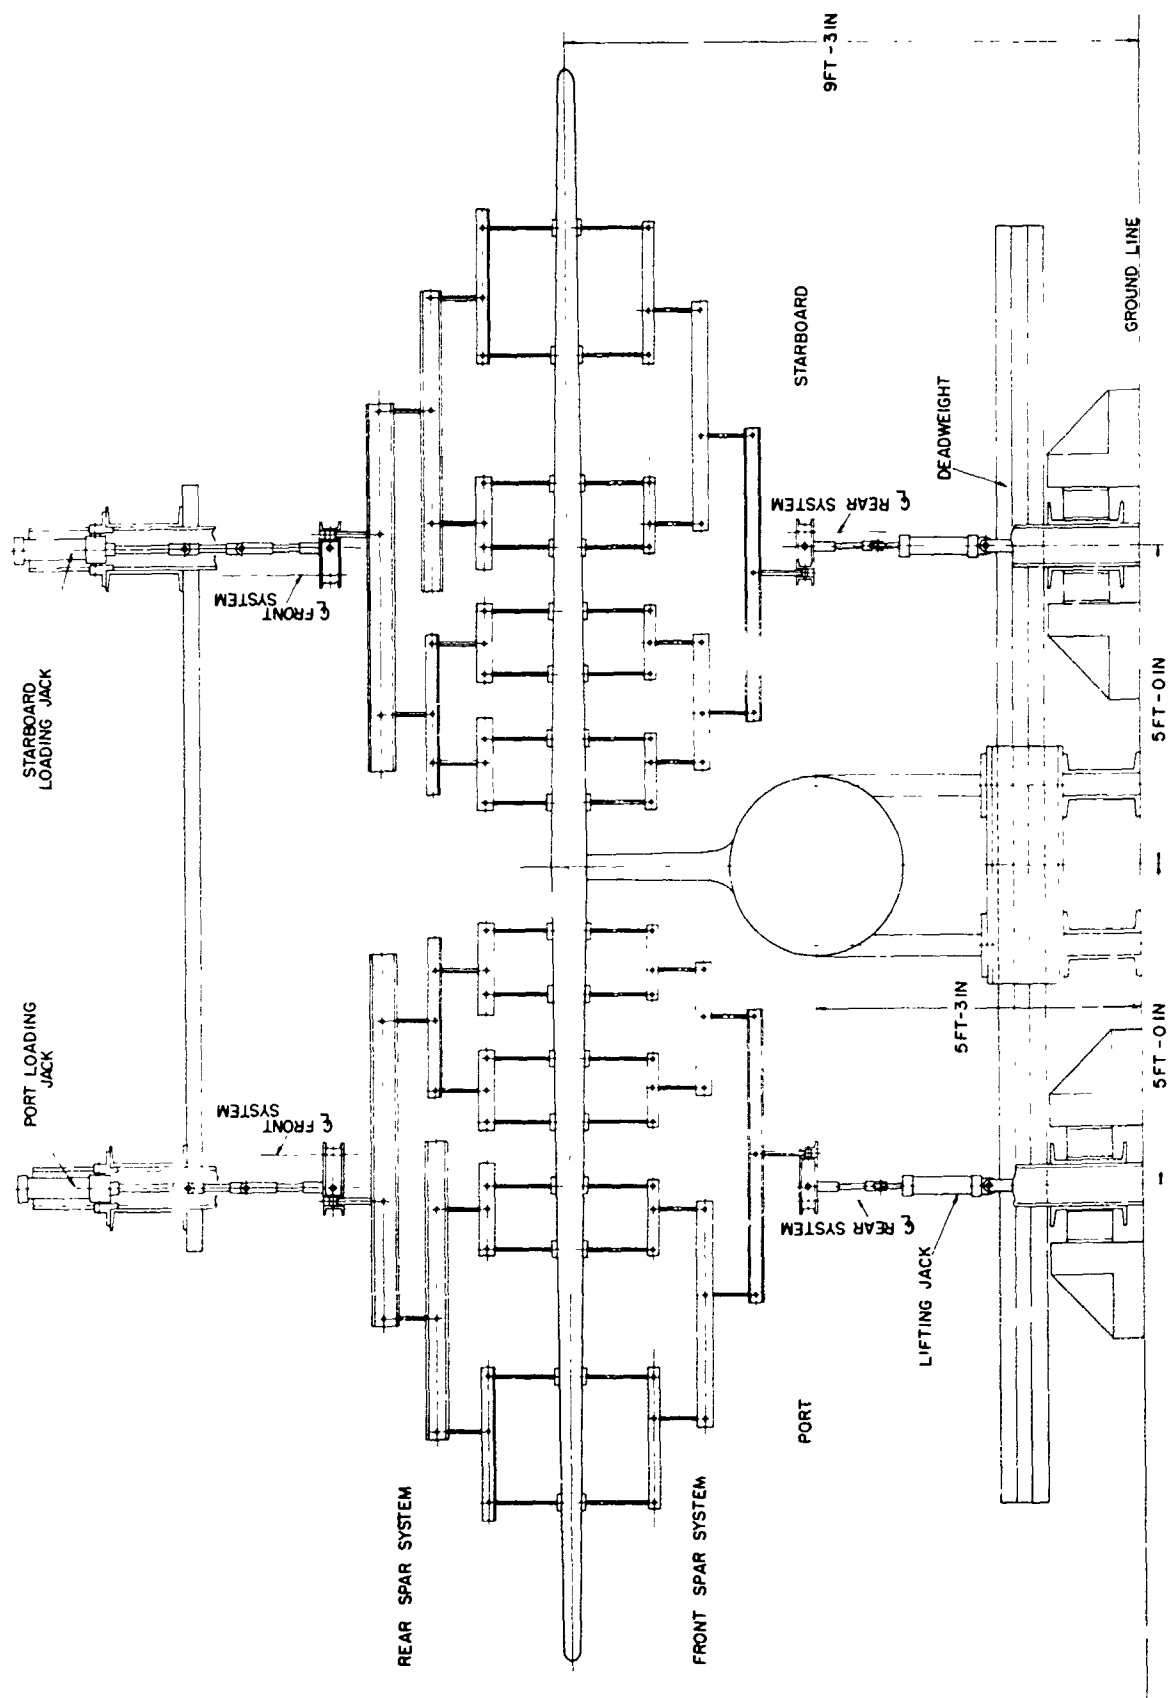
FIG. 34: C-100 TAIL UNIT TEST ARRANGEMENT -- REAR ELEVATION

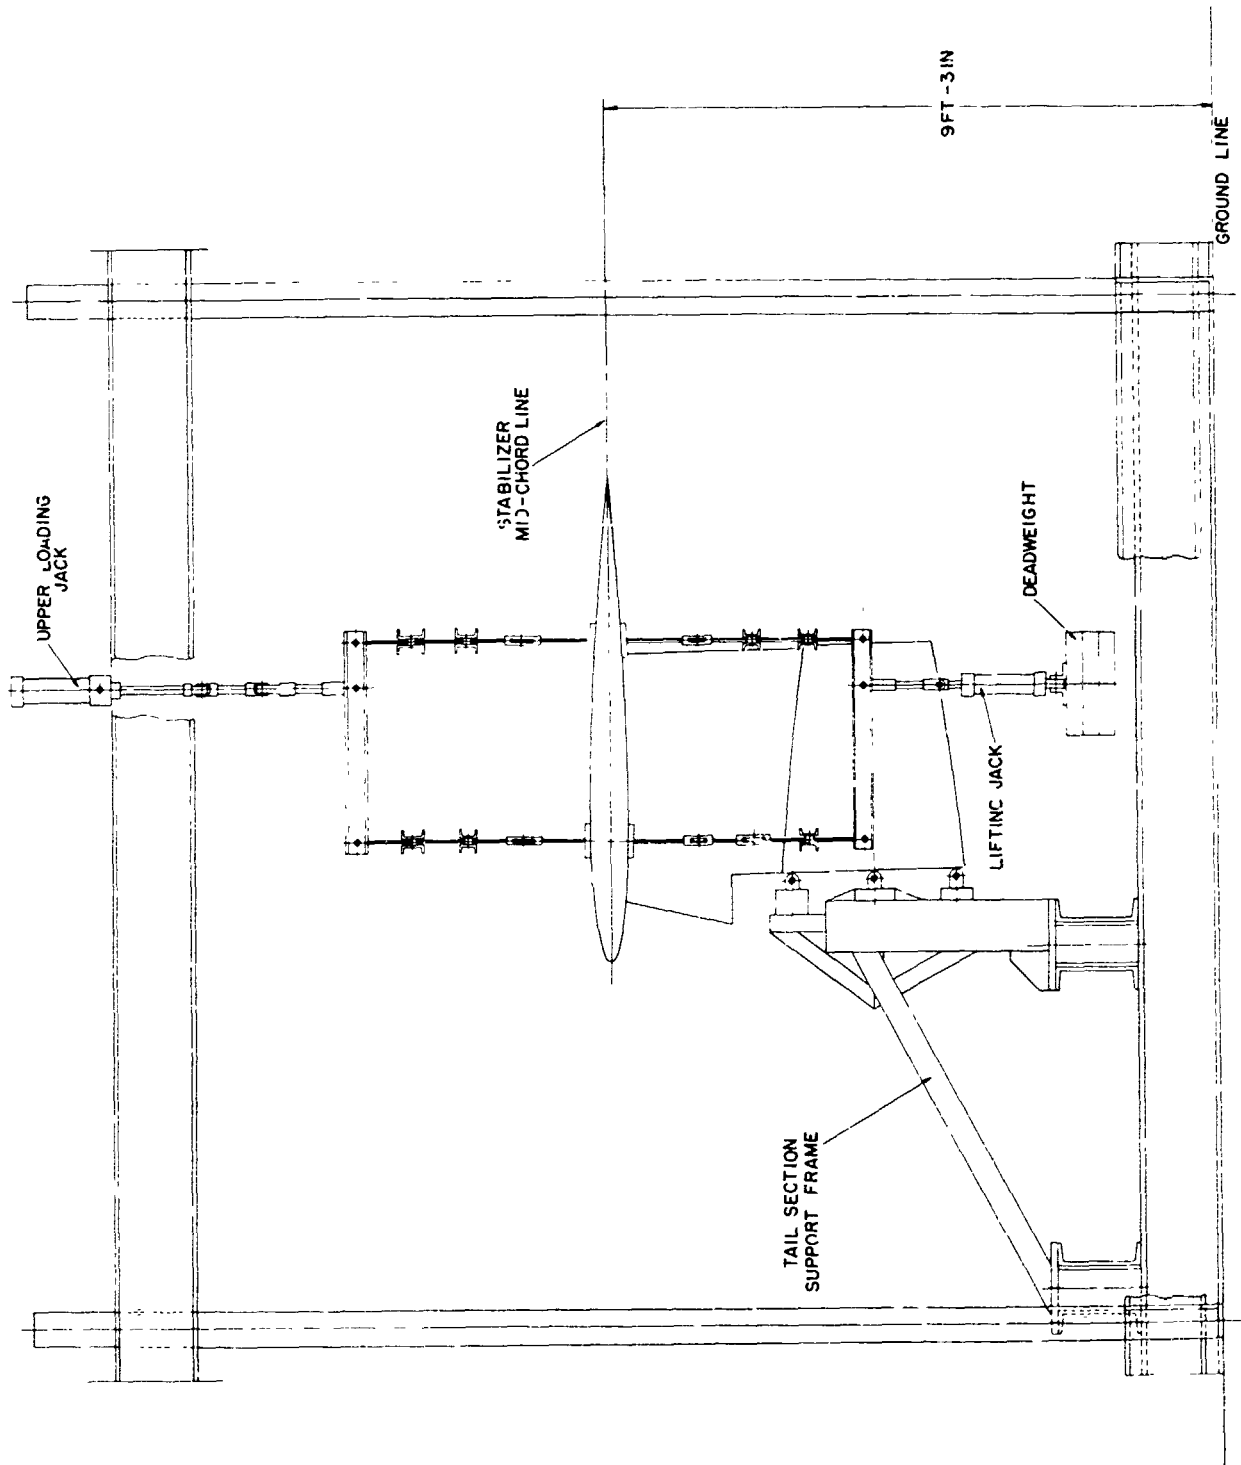
FIG. 35: C-100 TAIL UNIT TEST ARRANGEMENT - SIDE ELEVATION

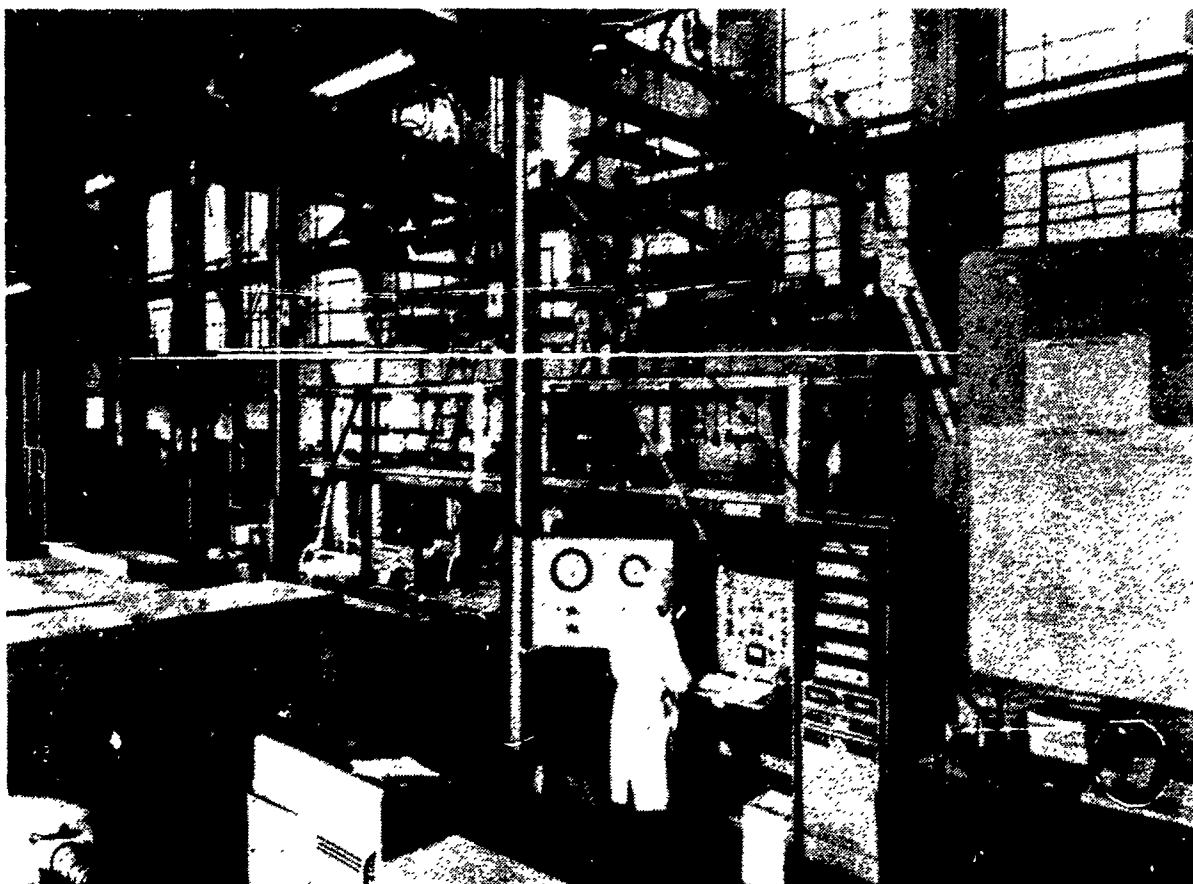
FIG. 36: C-100 TAIL UNIT FATIGUE TEST ARRANGEMENT

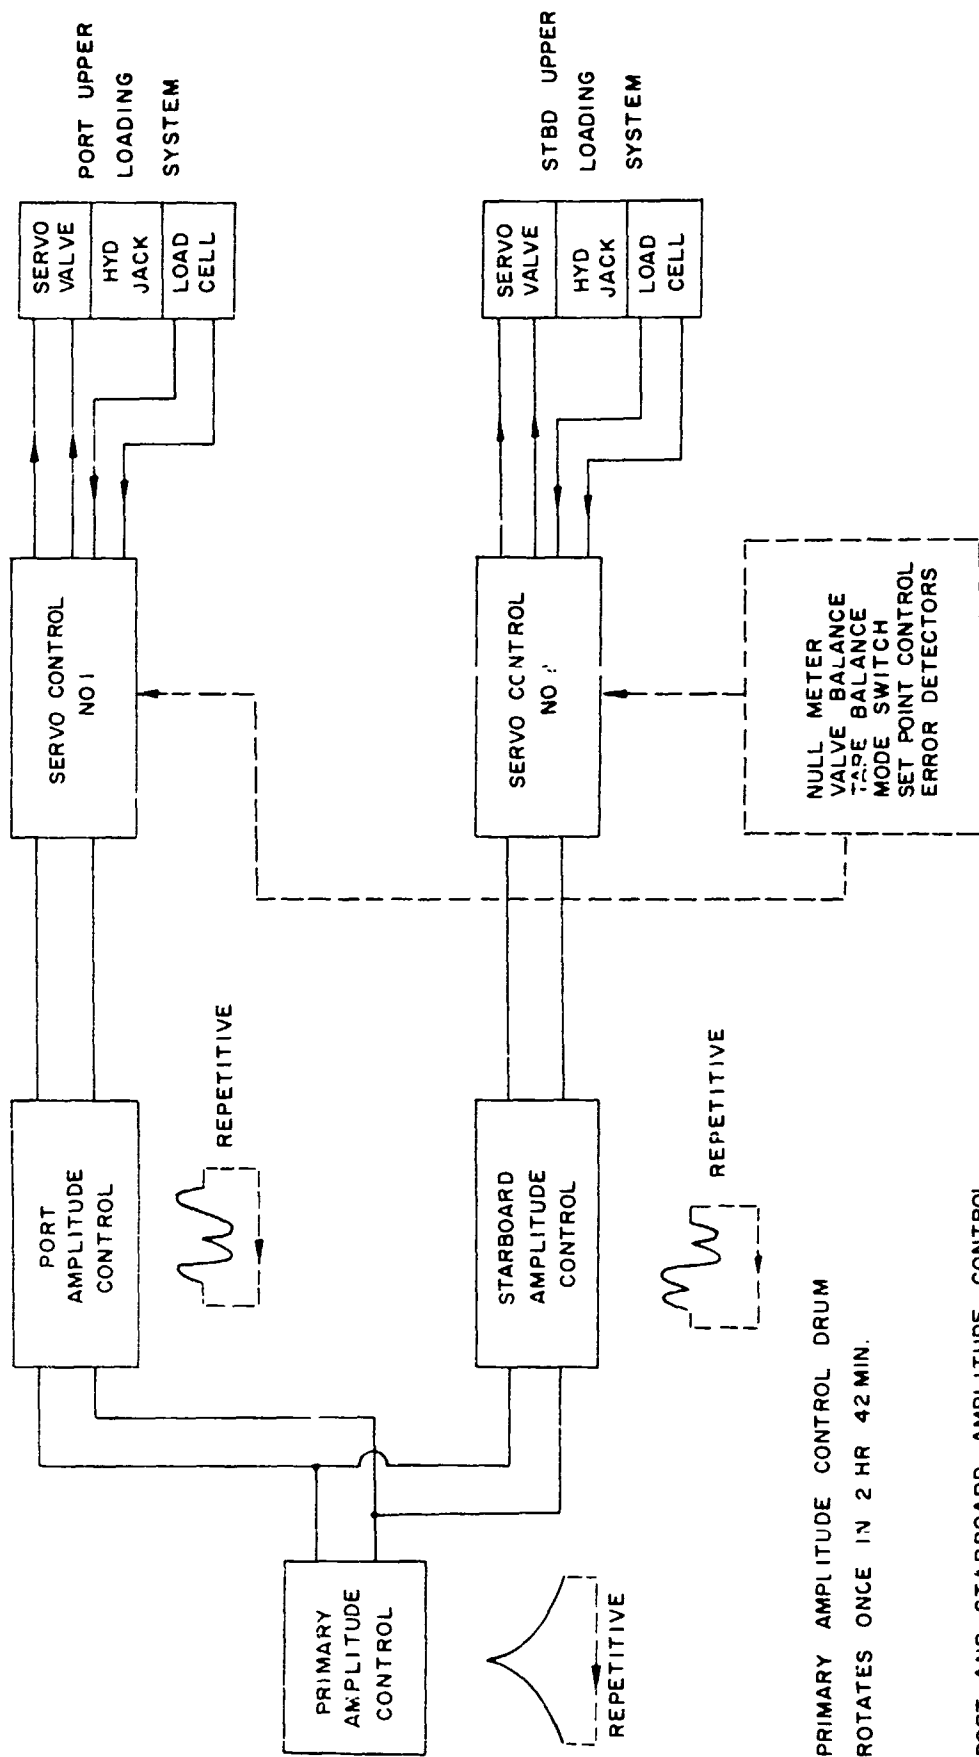
FIG. 37: BLOCK DIAGRAM OF LOAD CONTROL SYSTEM FOR C-100 TAILPLANE TEST

The load control system consisted of four basic units, a function generator, regulated d.c. reference voltage and discriminator, and programmable frequency control and amplitude control potentiometers. Programs were etched on conductive paper, the etched line dividing the surface into two electrically isolated areas. The paper was attached to a rotating drum and an electrostatic probe connected to a potentiometer followed the line to give an output proportional to the position of the line. The function generator generated a sine wave function in which the base frequency was varied by the control potentiometer so that the small cycles could be applied faster than the large ones. This output was then modified by a bias voltage to shift the mean to the desired level and then further modified by the amplitude control potentiometers which resulted in an output amplitude corresponding to the desired load history. This output was then divided by proportioning attenuators so that the signal being fed into each of the three servo-controllers was in direct proportion to the load requirements of each system. The load applied to the centre section lift system was maintained at a constant value throughout the test by a set-point adjustment of the corresponding servo control unit. The frequency was such that a complete 50 hour load block consisting of 454 cycles was applied in 2-1/4 hours.
